✓
DOT/FAA/CT-88/27

Electro-Impulse De-Icing Research (Fatigue and Electromagnetic Interference Tests)

Institute for Aviation Research
Wichita State University

Final Report

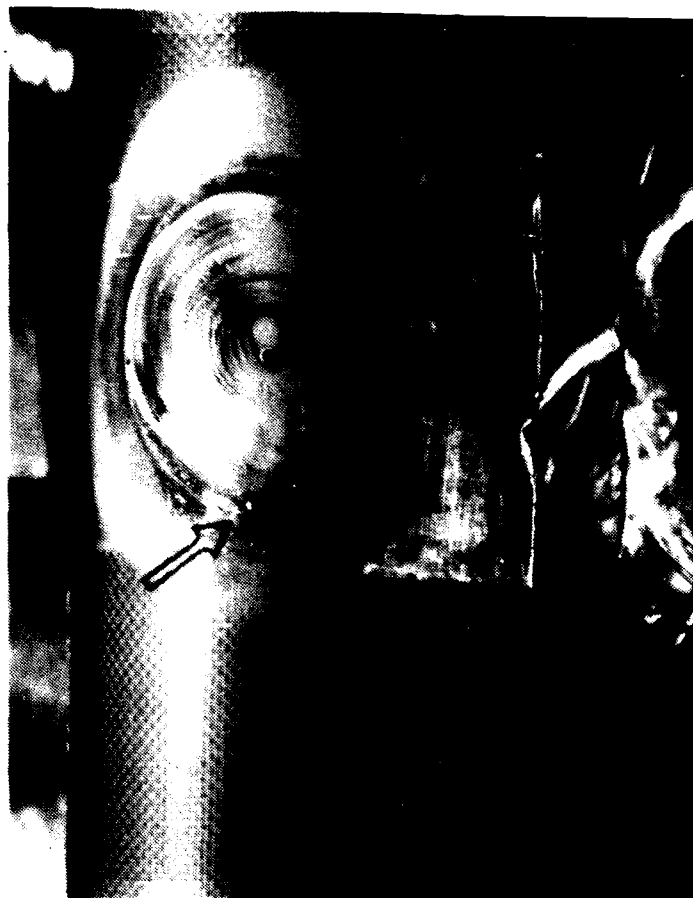
The coils had been made by Cessna with techniques developed at WSU. In the initial inspection, it was found that in one of the bays of each model, one of the coils had a connecting pin that was poorly covered by insulation, as shown in Figure 2-2. This was corrected by grinding the pin and covering it with fiberglass and epoxy. This would likely have caused a short across the 0.1 inch gap between the coil and doubler. The short could be dangerous to personnel as well as seriously reducing the de-icing capability of the unit.

Figure 2-2
Coil Mounted on Semi-Cylindrical Beam. Poorly
Insulated Pin is on Left Side of Coil.

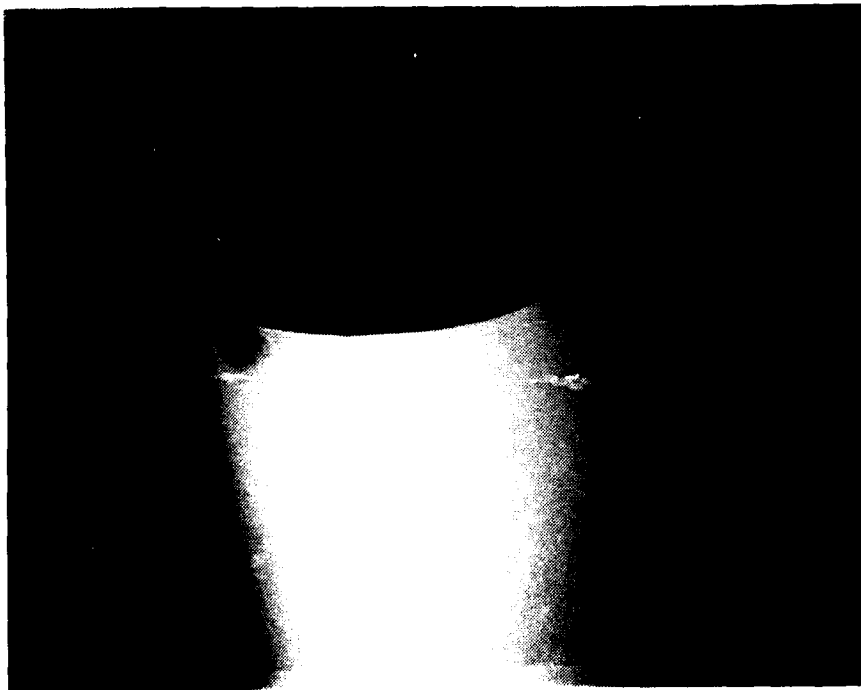
The two leading edge models were inspected upon delivery from Cessna. It was found that the outboard rib on the thin-skin model was a special, hand-installed closure rib. The rivet holes appeared to be hand drilled and hole alignment was imperfect. This rib was not bonded as were the other ribs. Where poor hole alignment occurred, the rivets created a slight

pucker in the skin, putting extra stress on the rivet. The thick-skin model also had a non-standard, non-bonded outboard closure rib.

At 3,400 impulses, inspection revealed fretting had begun around two rivets on the outboard rib, and at 7,500, these rivets showed signs of peeling, as shown in Figure 2-3. The inspection at 7,500 impulses showed no signs of debonding, cracking, delamination of the coil support beam or deformation of the skin.

Figure 2-3
Rivet Hole Failure
After 7,500 Impulses
(0.025 Inch Skin)

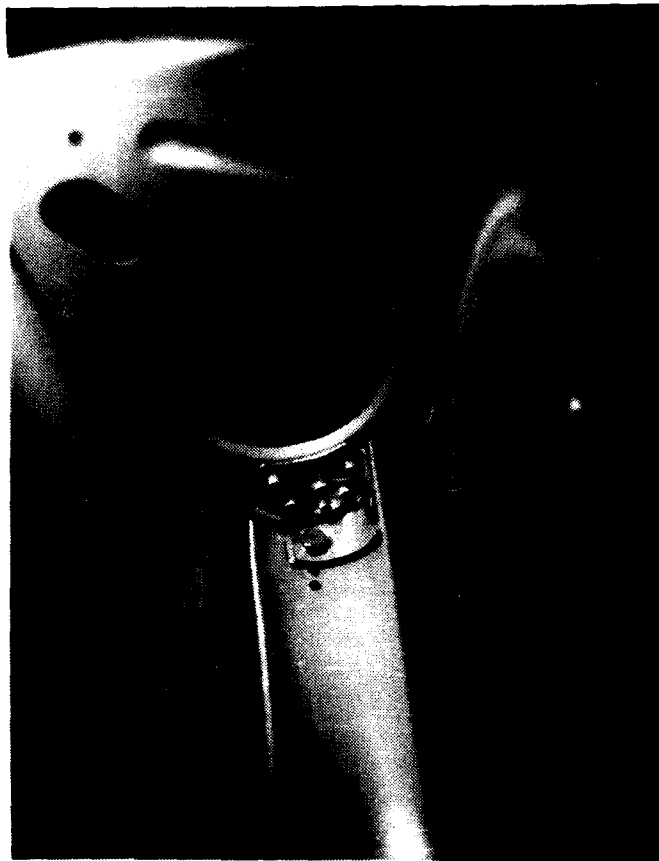
At 11,200 impulses, a change in sound was detected, and the inspection covers were removed to reveal a broken coil-beam mounting bracket in bay number 2, as shown in Figure 2-4. Since the bracket was still lodged in place, no change in current trace was indicated.

The results both relieve fears about fatigue damage and give warnings about fatigue. For the structure made by standard manufacturing methods, no debonding, cracking or deformation took place. But for a poorly designed mounting bracket, a warning is sounded. This stretch-formed aluminum bracket was not well suited to a system with fatigue possibilities. A stronger bracket is obviously required. A machined bracket with large radius fillet would avoid the stress concentration.

Figure 2-4
Broken Bracket
After 11,200 Impulses
(0.025 Inch Skin)

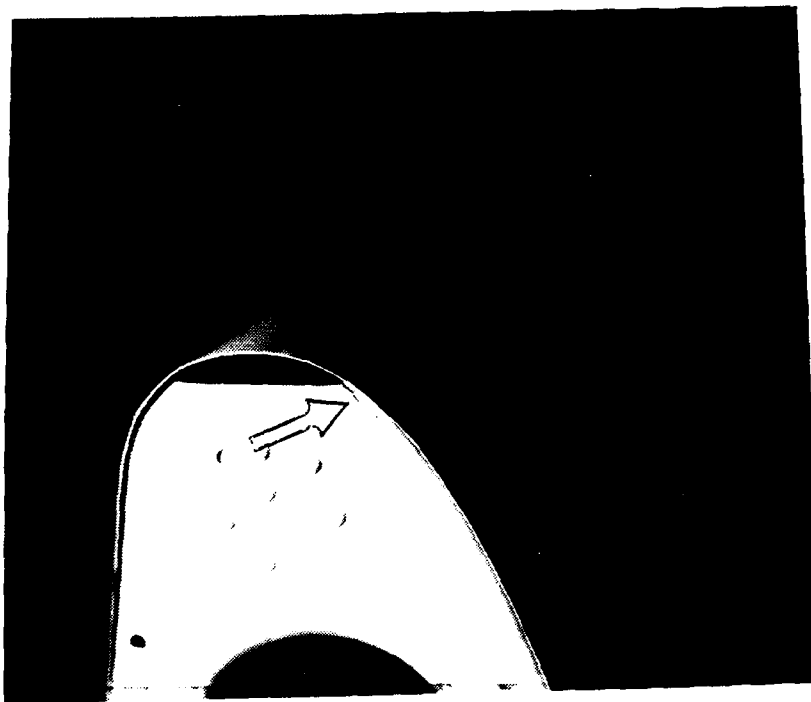
After 15,000 impulses, disassembly and inspection showed a hairline crack in the outboard end closure ribs, shown in Figure 2-5. No other damage could be detected. The stability of the electrical parameters can be seen in the data of Table 1, and in the current trace in Figures 2-6 and 2-7.

Similarly, the end closure rib which was rather casually inserted, showed the danger of ignoring fatigue considerations. The rivet holes misalignment and failure to bond the rib led to hairline cracking. The main conclusion is that fatigue is a solvable problem, but the EIDI system can cause fatigue breakage when stress concentration points are permitted in the design.

Figure 2-5
Hairline Crack on End Rib (Crack is at Upper
Right Corner of Rib) (0.025-Inch Skin)

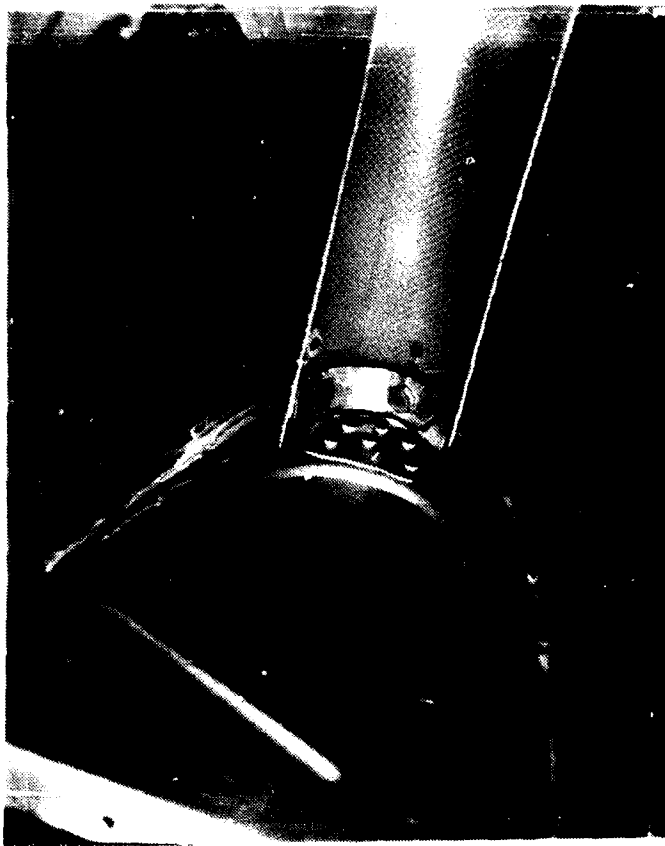
At the 7,500 impulse disassemble and inspection, no changes could be detected. At 11,700 hits, a change in peak current was noted for the bays 1 and 3 circuit. Inspection revealed that a coil beam mounting bracket had broken as shown in Figure 2-8. The coil mount had shifted about 0.10 inches, which had caused the change in peak current. At the end of the test of 15,000 impulses, disassembly and inspection revealed that bays 2 and 4 also had cracks in one of their mounting brackets; these are shown in Figures 2-9 and 2-10. There was also a hairline crack in the nose of the outboard closure rib (Figure 2-11). Current traces are shown in Figure 2-12 and 2-13.

Figure 2-8
Broken Bracket on 0.040-Inch Skin
Model (Bay 3) After 11,700 Impulses

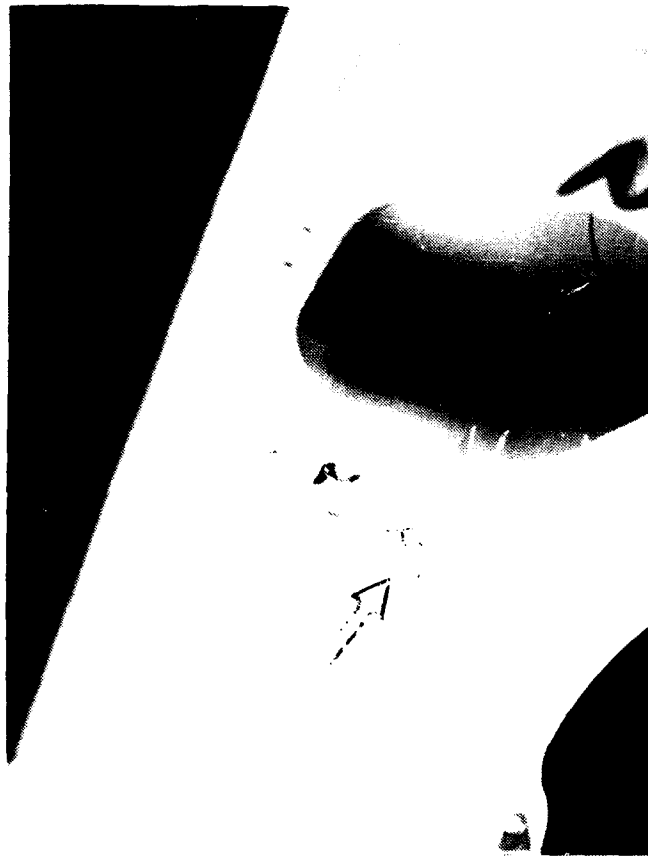
Figure 2-9
Broken Bracket on 0.040
Inch Model (Bay 2).

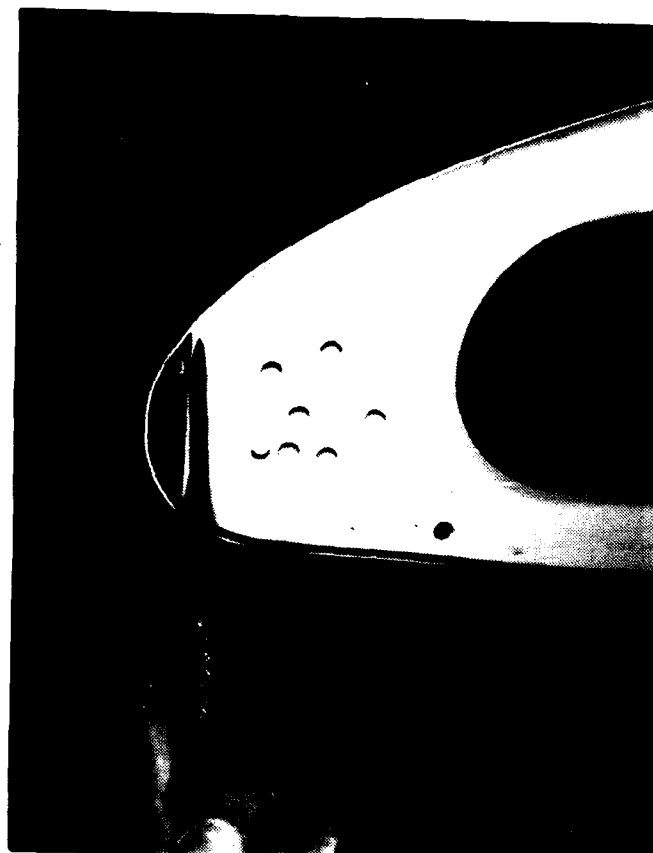
Figure 2-11
Hairline Crack on End Rib
of 0.040 Inch Skin Model
